KJMM Range Land Application Site Plan - 120417

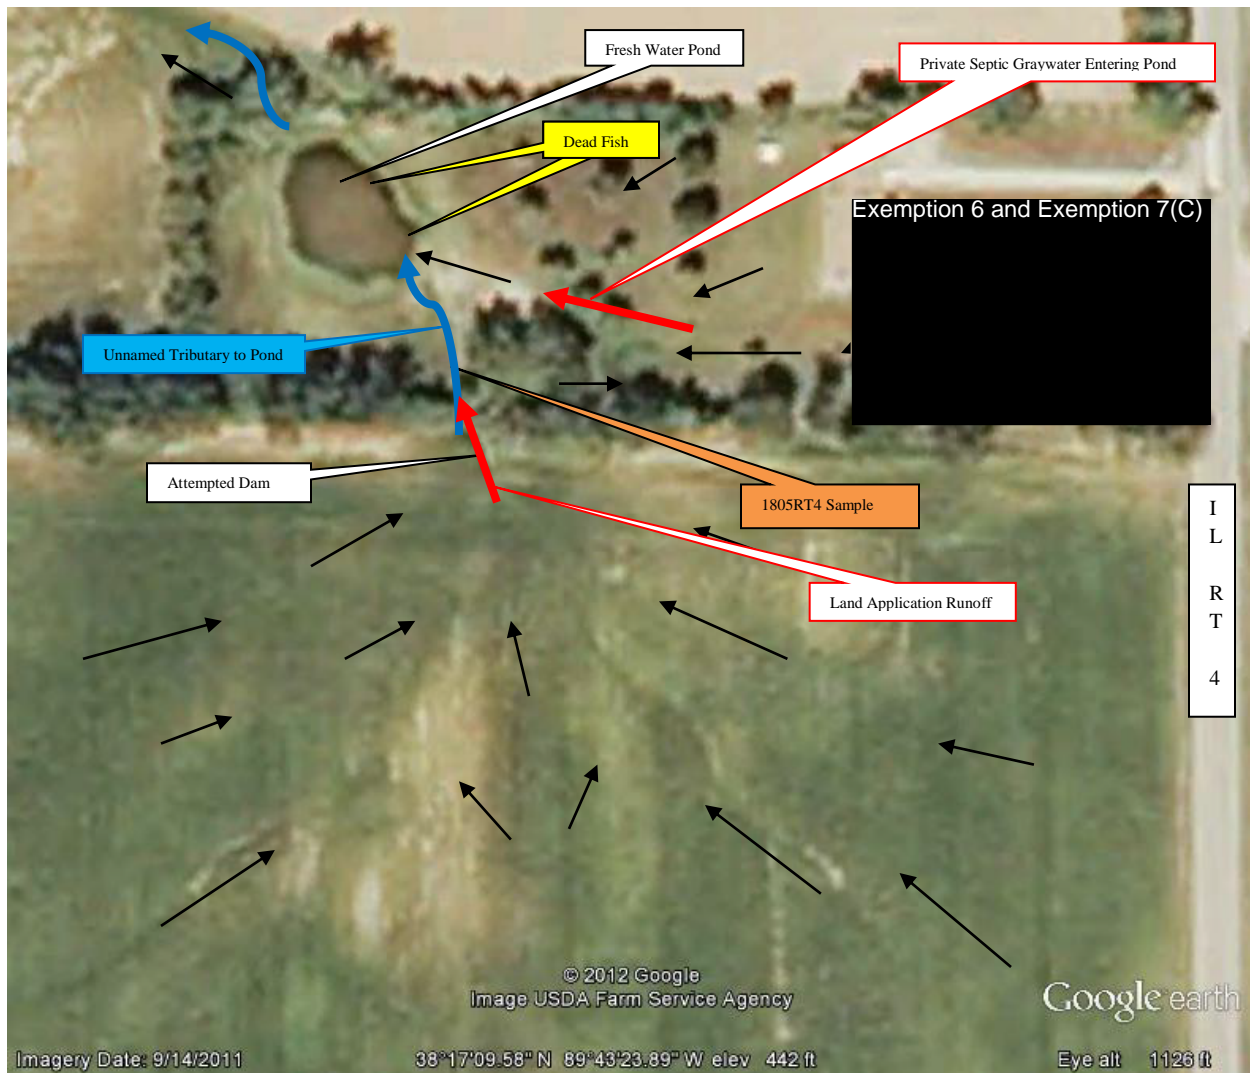
Black arrows show the direction of storm water drainage. Blue arrows show the direction of fresh water travel in the unnamed tributary through the private pond. Red arrows show nutrient laden water flow from manure application in the field and gray water associated with a residential sewer. The property line is approximated by the tree line on the north side of the land application field. An orange reference shows where a sample was taken in the unnamed tributary immediately north of the land application field. Small dead fish were noted in the pond at locations identified with a yellow descriptor. Land application appeared to occur approximately 100 feet south of the unnamed tributary reporting to the pond located on the adjacent property. There appears to be an attempt to dam up manure runoff in the field ditch where shown on the site plan. See photo pages for dam, fish, and water conditions.
